TWR-17543, Vol. VII
ECS 1012

FLIGHT SET 360T004 (STS-30) FIELD JOINT
PROTECTION SYSTEM FINAL REPORT

20 September 1989

TWR-17543 Vol. VII
Flight Set 360T004 (STS-30)
Field Joint Protection System Final Report
Volume 7
Final Report

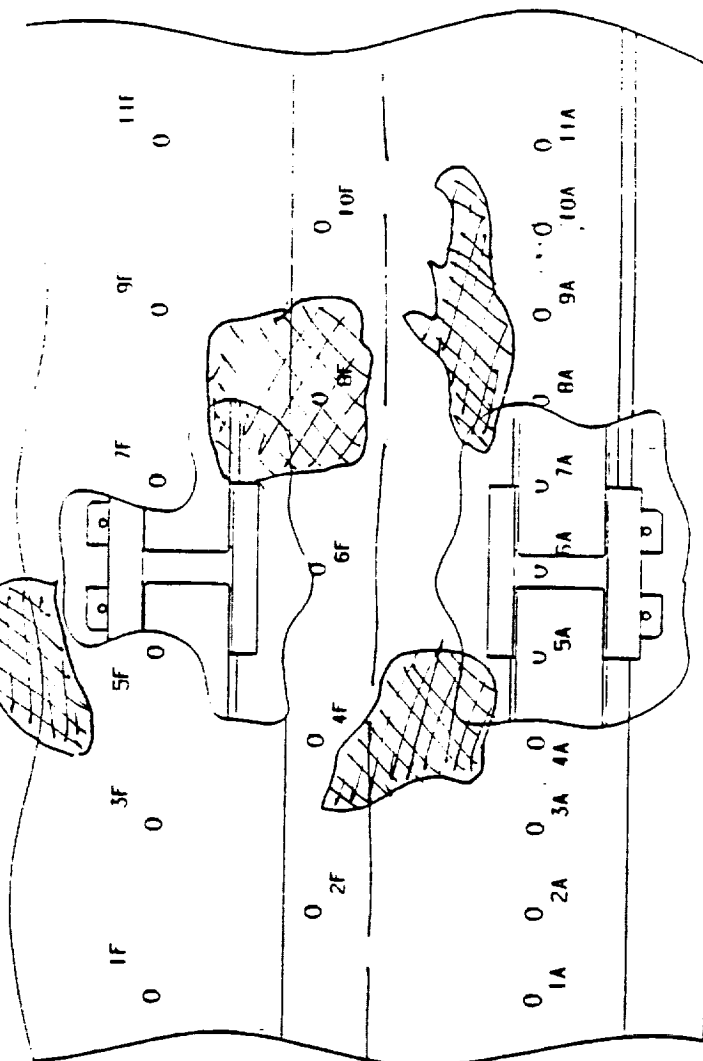
Deep Void (0.4 inch)

The aft strap
should be shifted
6 scale inches
to the right to
represent the actual
orientation.

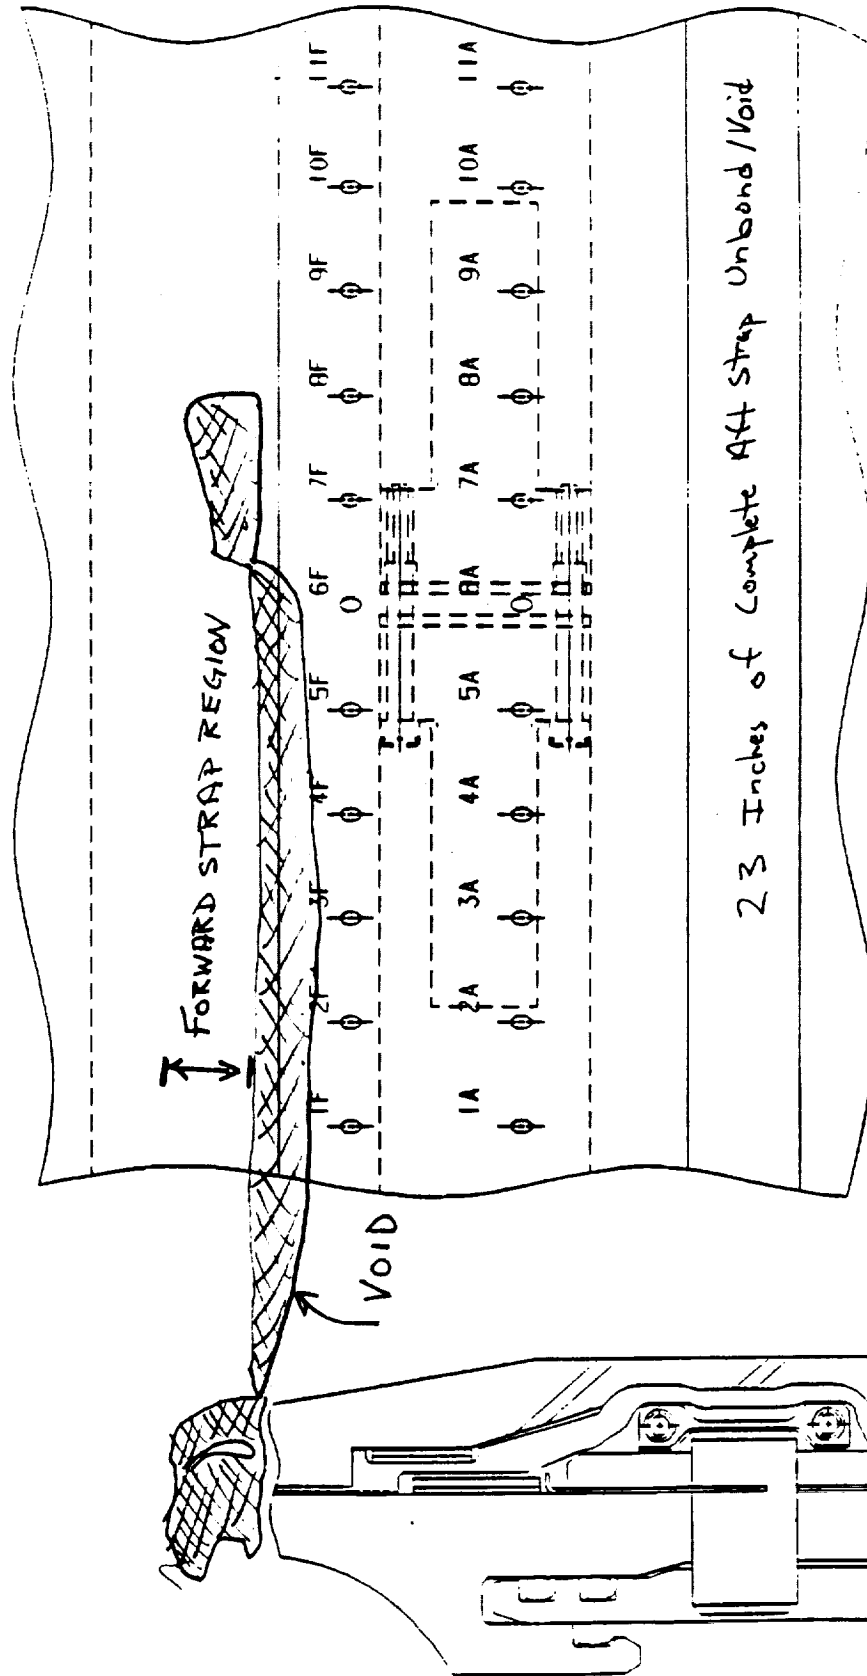
23 Inches of Complete Aft Strap Unbond/Void
